## BMW 6 Series (E24) Instrument Cluster Light Upgrade Odometer Gear Replacement

## E24 odometer gear replacement - airbag car DIY

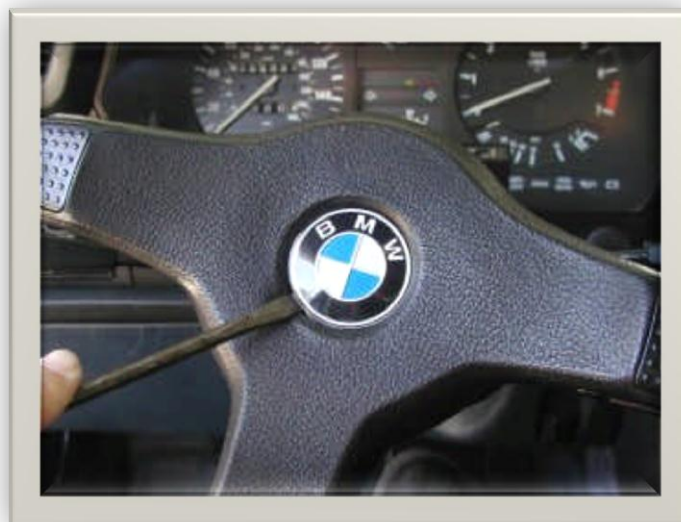
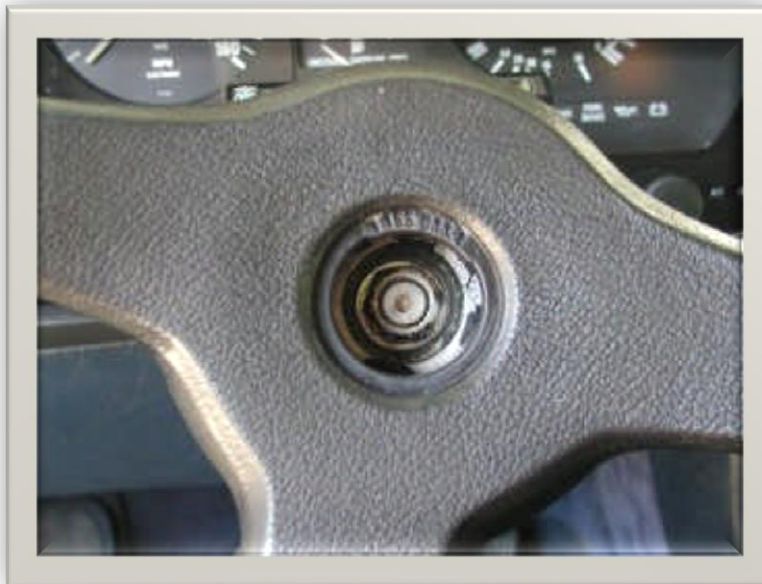
Using a bladed screwdriver

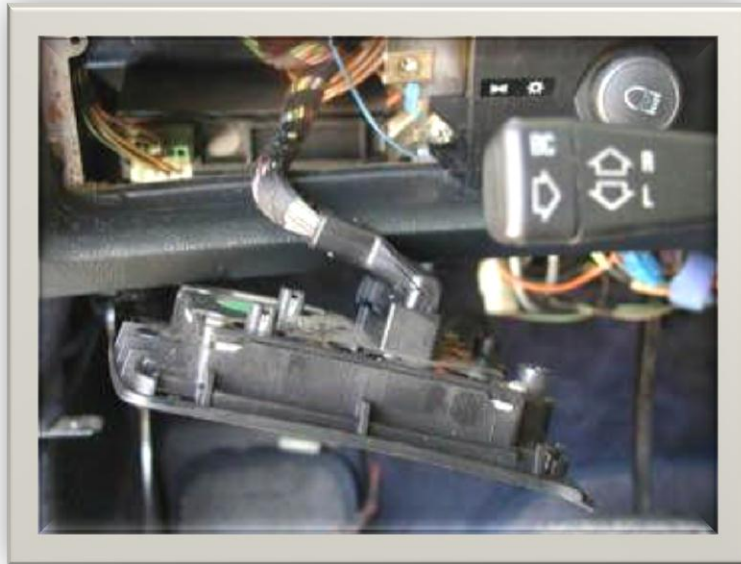
Remove 3 screws holding the check panel module in place.

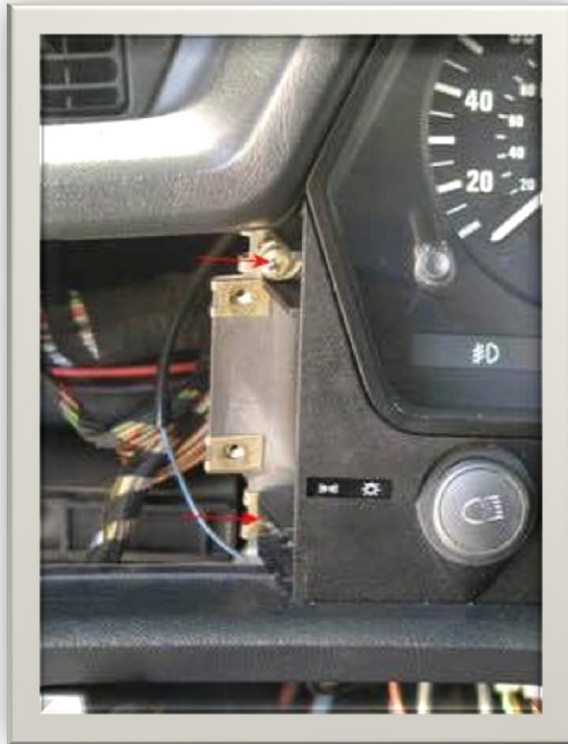
Remove the 2 right side instrument cluster mounting screws.

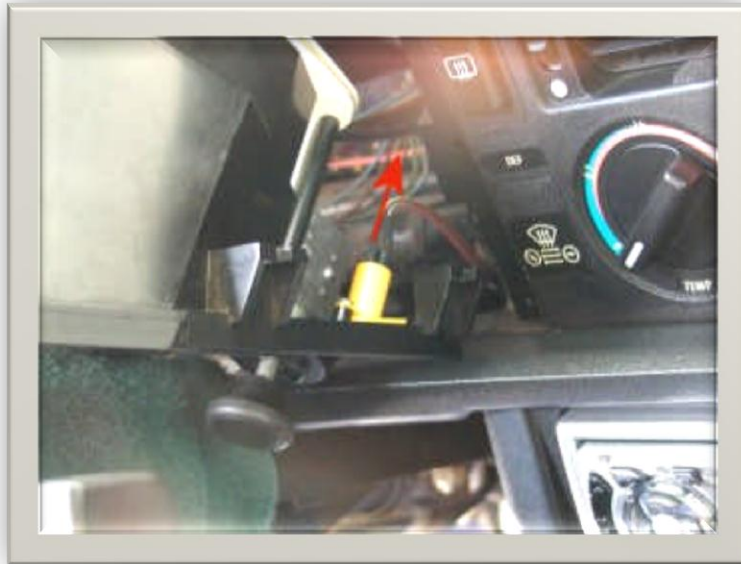
Place a thick towel or other padded covering over the top of the steering column. Gently pull the instrument cluster out to lay face down on the top of the steering column.

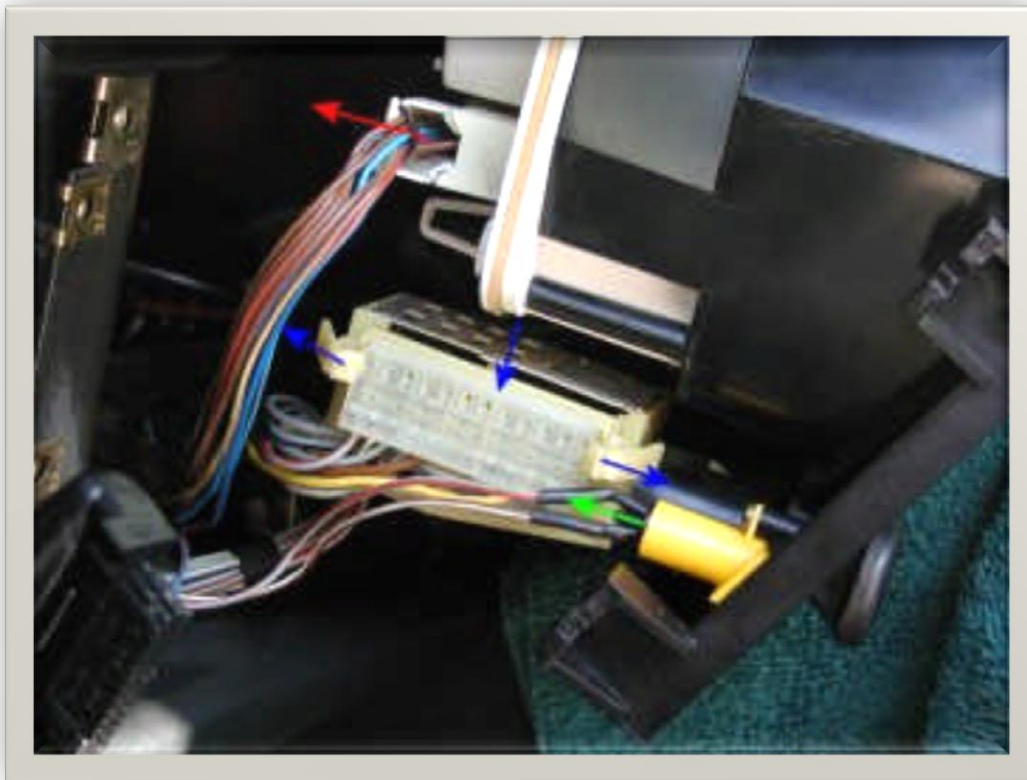
Remove the fog light switch light bulb by pulling the bulb straight out of the yellow holder.

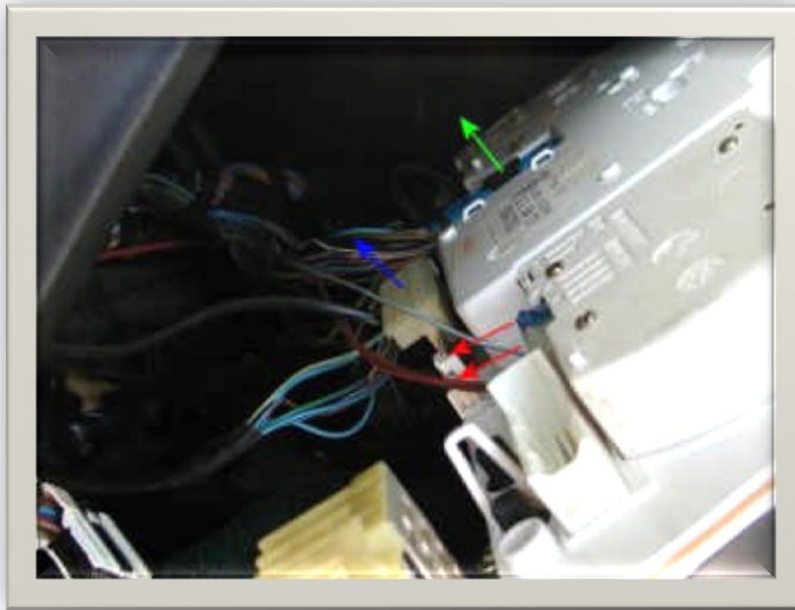
Remove the head light switch light bulb by pulling the bulb straight out of the yellow holder (green arrow).

While spreading the 2 locking tabs, disconnect the headlight wire bundle connector (blue arrow). Be careful to pull the connector straight out and to not break the connector.

Disconnect the speedometer wire bundle (red arrow). Be careful to pull the connector straight out and to not break the connector.

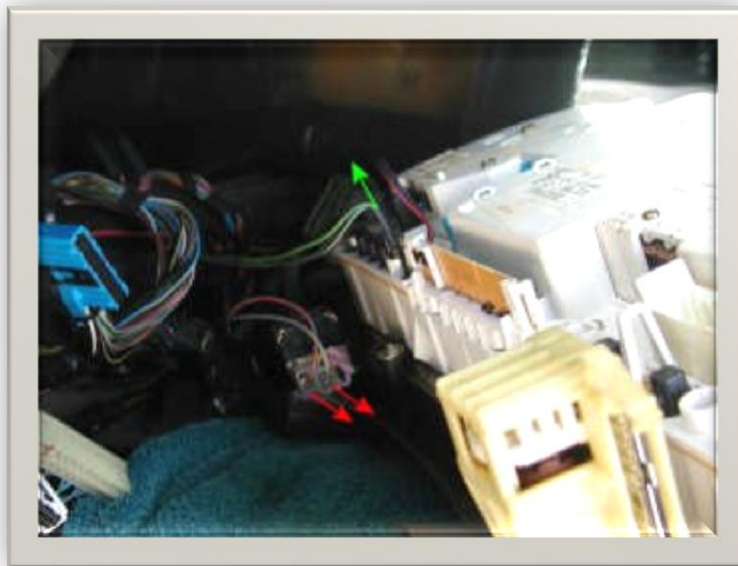
Disconnect the odometer wires (red arrows), the main SI board bundle connector (blue arrow), and the Gas/Temp gauge bundle connectors (green arrow). Connectors should be disconnected in the direction of the arrows. Be careful to pull the connector straight out and to not break the connector.

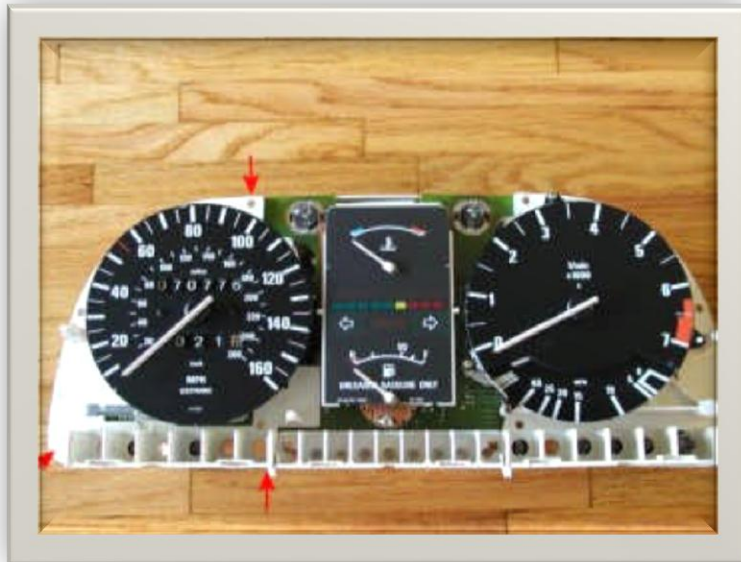
Remove the 8 instrument cluster screws. Gently pull the instrument cluster electronics straight up and out of the body. Set the body and the pillow aside.

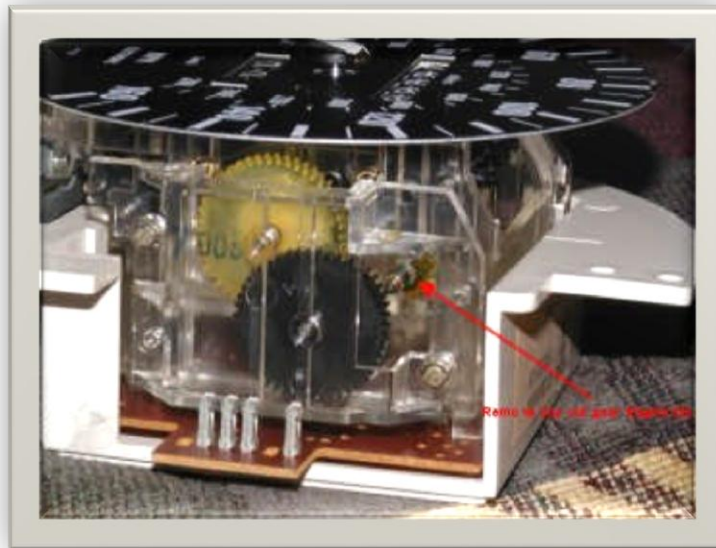
Lay the cluster assembly face up on a sturdy surface. The speedometer is attached to the circuit board by a pin connector on the circuit board. At the points indicated, gently rock, lift and disconnect the speedometer from the circuit board. Be especially careful not to touch and damage the instrument needles. They are easily bent. Set the remainder of the instrument assembly aside where it cannot get damaged.

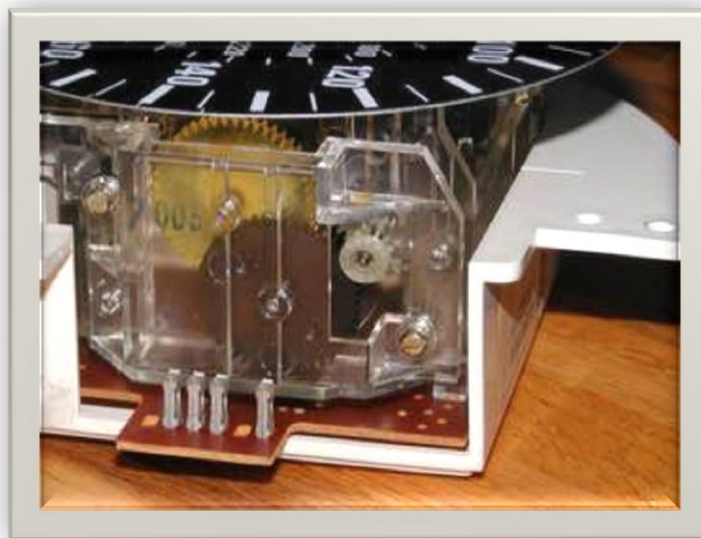
The reason the original gear or gears have failed is that they are made of urethane and lubricated with petroleum grease. This combination breaks down the urethane into a waxy substance which flakes and breaks away. This will also leave a waxy film and deposits on the shafts, gears, housing and peg on the pods.

Inspect the gears on the right side of the speedometer. It is advisable to replace the first three gears as they will all fail.

\*First remove the clear cover

\*Remove all of the gears

\*Pull the two shafts out with pliers that the larger gears were on

\*First remove and put aside the four rubber spacers that are on the rear of the speedometer circuit board. Blow everything out with high pressure compressed air. You cannot use too much pressure. Use the air throughout the unit. Any small pieces of the old gear can disable the odometer as the motor is not very strong. After using the compressed air inspect the unit for any stray pieces.

\*Wipe clean all areas where the gears sit: plastic cover, housing, metal shafts, plastic original gear that is not replaced. Any residue that is left from the old gears and grease can cause the new gears to stick and not work properly.

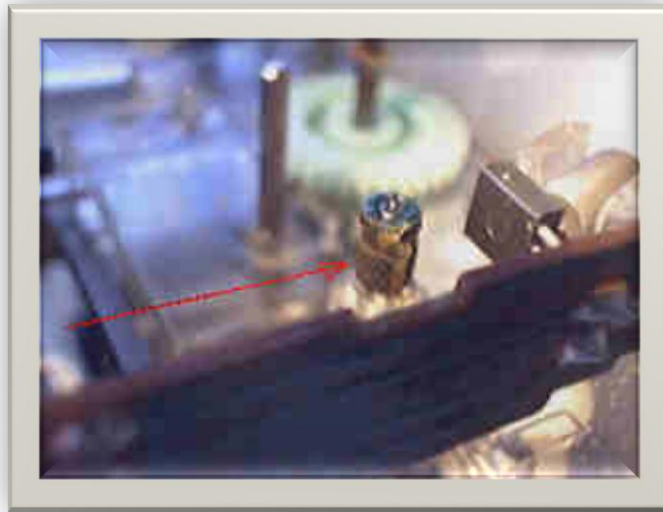
### Brass gear that needs to be removed and discarded

\* (You are going to deform the bushing so that it can be removed. **Wear safety glasses because the bushing can break and fly off**) with side cutters (dikes, wire cutters), squeeze brass fitting where small gear was, across the diameter with a firm handshake grip. Then turn the shaft two clicks and repeat with a firm handshake grip. Put the tool down and remove the brass bushing with fingers. If it does not remove with your fingers, repeat using the side cutters until it comes off. **DO NOT USE ANY TOOLS** to pull the brass bushing off as this could damage the motor. You do not need this bushing with the new gear. Press the new gear on starting with the larger side of the hole in the middle of the new gear using your fingers, Hold the motor side cover while pressing on the new gear. Only press the new gear on to where the top of the shaft and the top of the gear meet. There should be a small amount of up and down movement of the shaft, this has to be there.

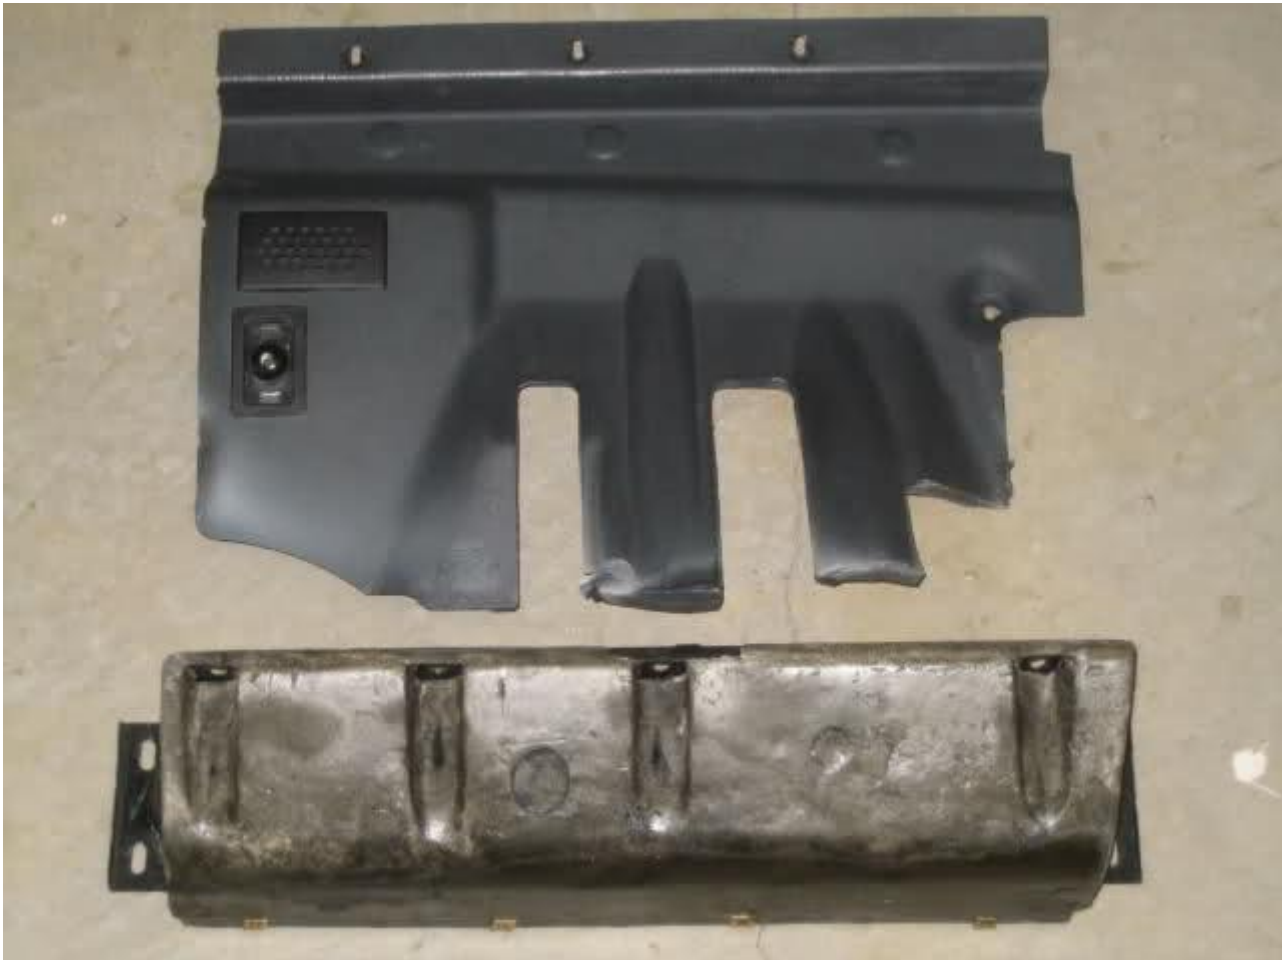
The cabin temperature sensor vacuum hose and the chime attach to a separate panel instead of to the rear of the knee panel. After removing the four screws along the lower front edge of the knee panel, remove an additional four screws from the second panel, which is the upper item shown in the following photo. This secondary panel is located under the dash and parallel to the floor. Detach the hose and electrical connector from the left side and set the panel aside.

Remove the bolts holding the steel reinforcement panel (the lower item in the first photograph) and set the panel aside. This provides access to remove the two bolts holding the steering column. Lower the steering column. I supported the column but that did not seem necessary. In contrast to the original instructions, there is no need to remove any of the trim from the bottom of the steering column.

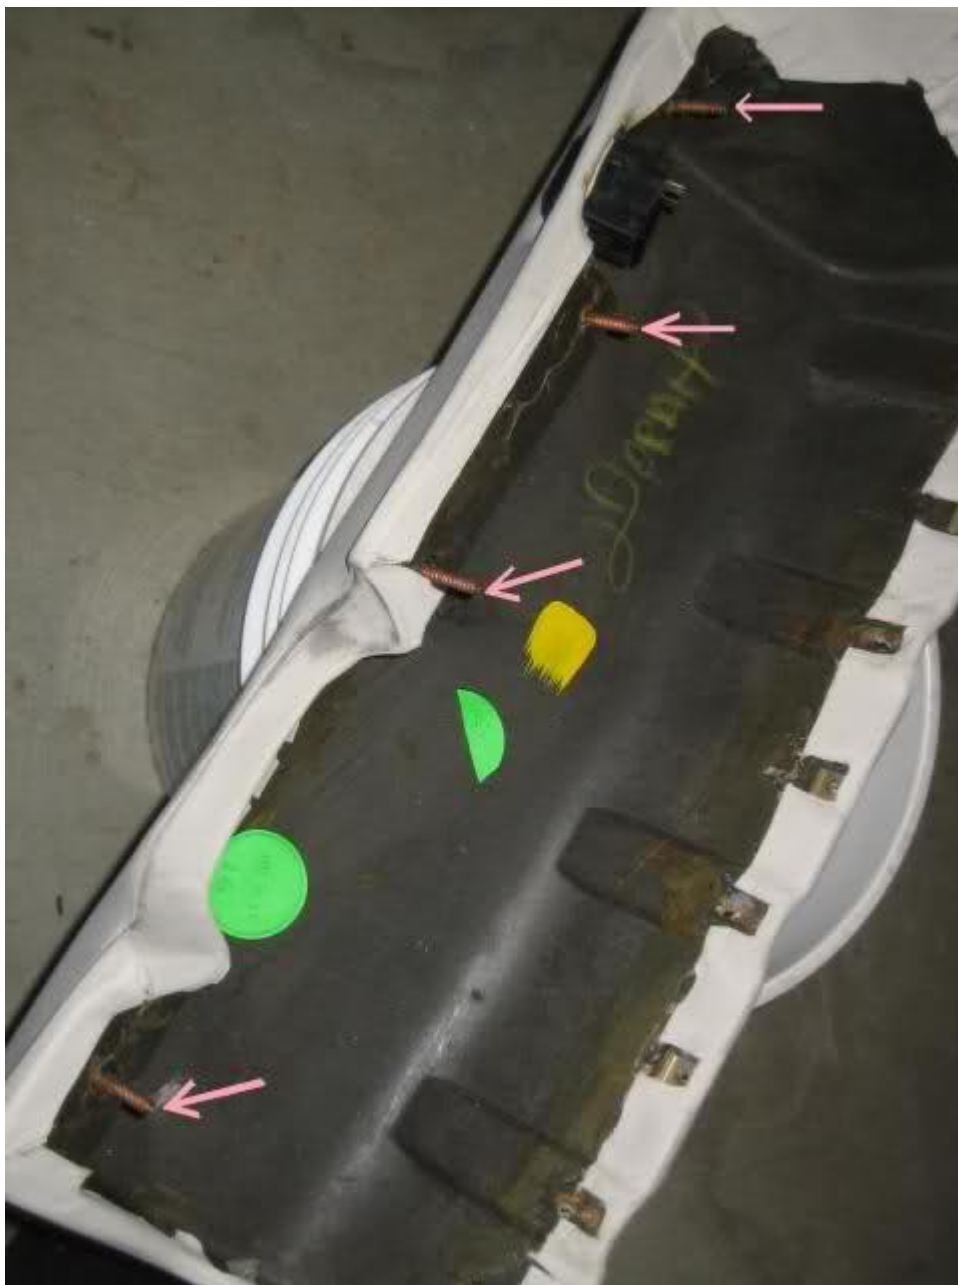
The knee panel (pictured from the rear in the next photo) is held in place by four friction-fit screws. These screws fit into the panel

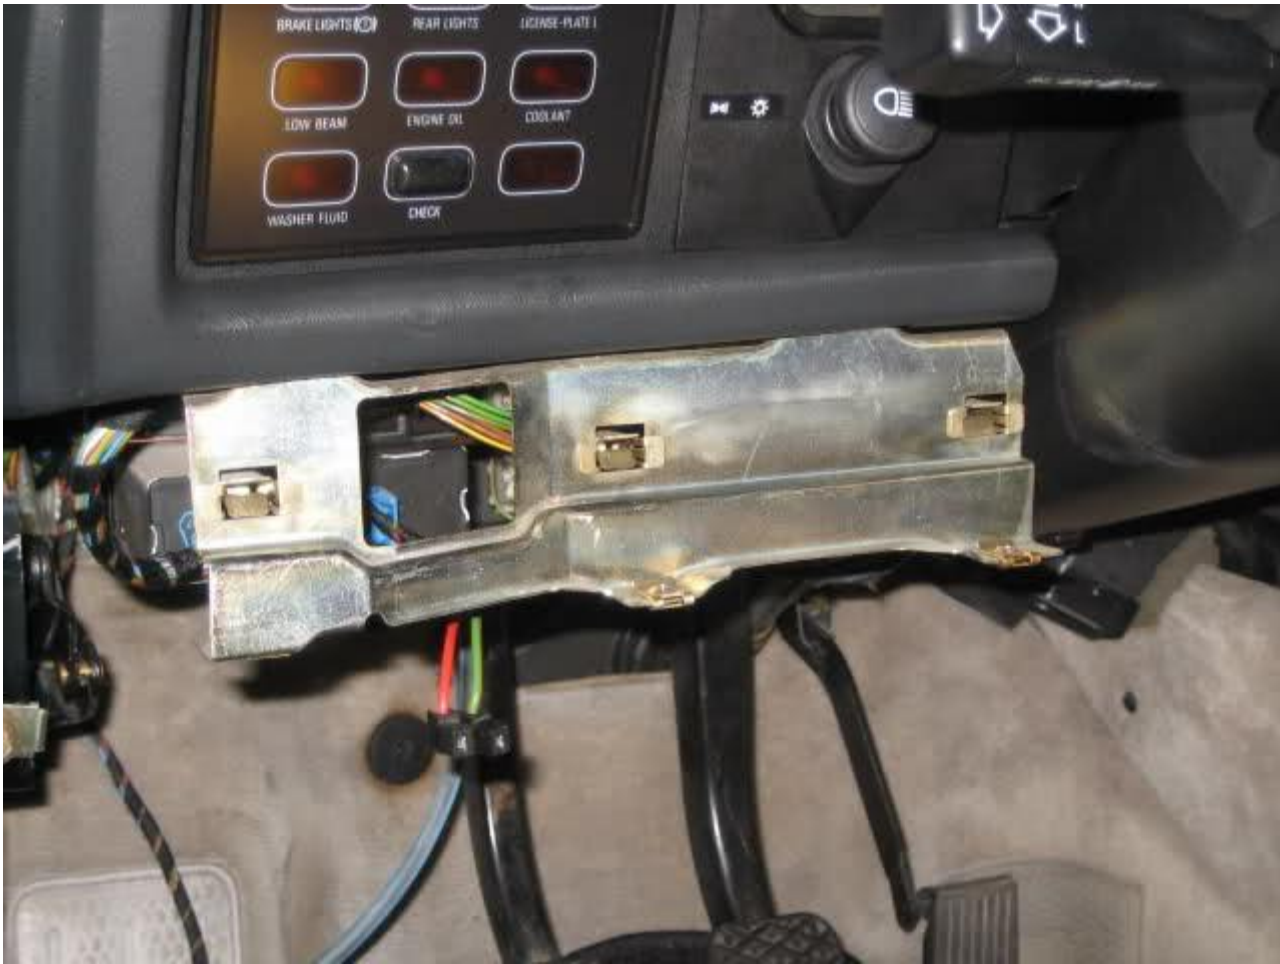
pictured below, which shows only the three screw holes to the left of the steering column.

Free the knee panel by pulling it straight toward the rear of the car. Disconnect the wires to the breaker switch and set the knee panel aside.

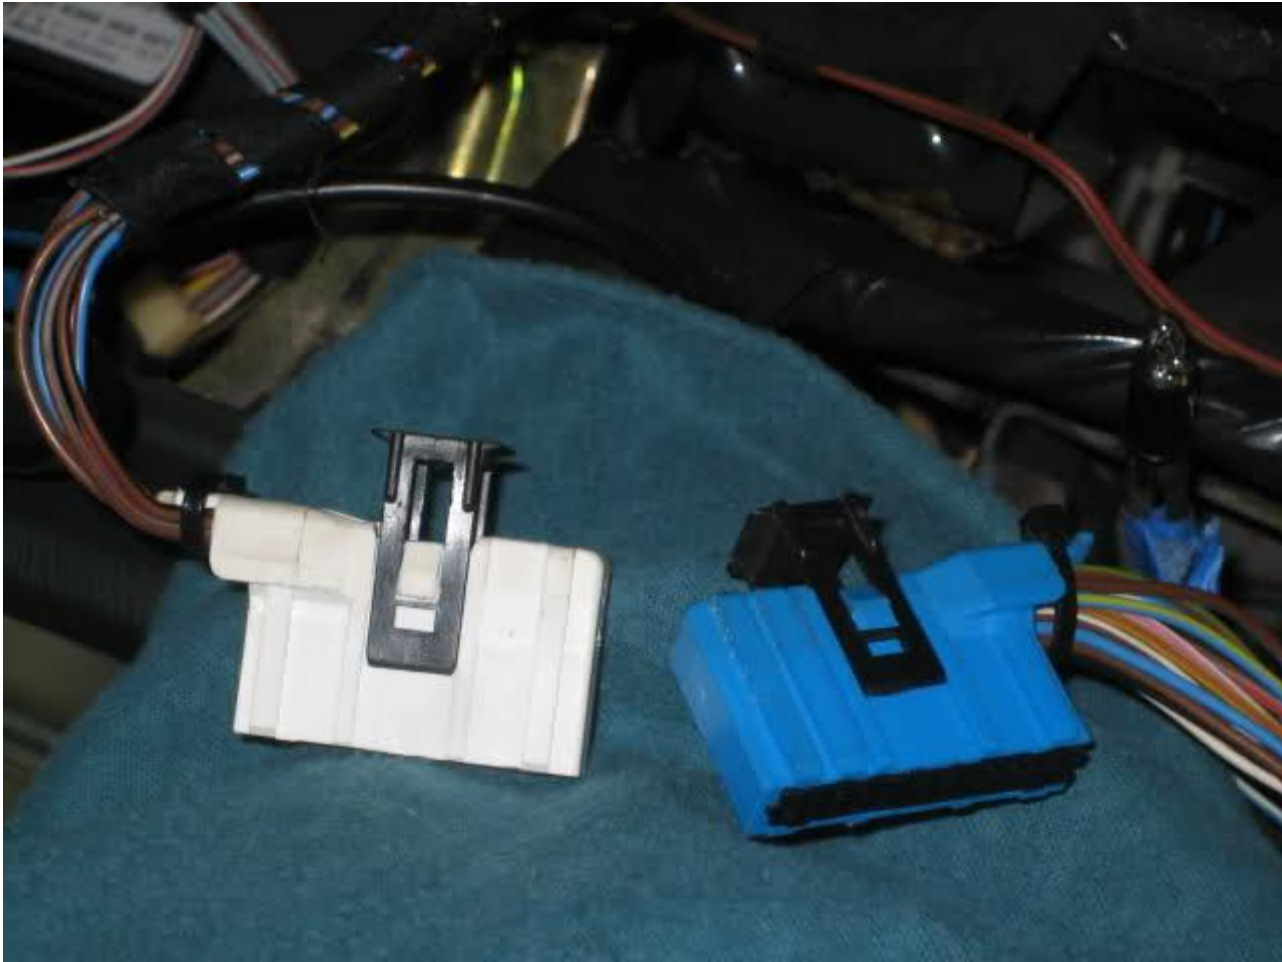
After removing the check panel on the left and cover on the right, remove the four screws to free the instrument cluster. Cover the steering column with a towel or soft cloth. Wiggle the cluster toward the rear of the car and tilt the top slightly toward you. This provides access to remove the connectors from the rear of the cluster. Although several connectors are color coded, I labeled them to aid reassembly. Gently use a smaller screwdriver to pry straight up and release the black plastic clips on the two main connectors (photo below), then pull those connectors straight out.

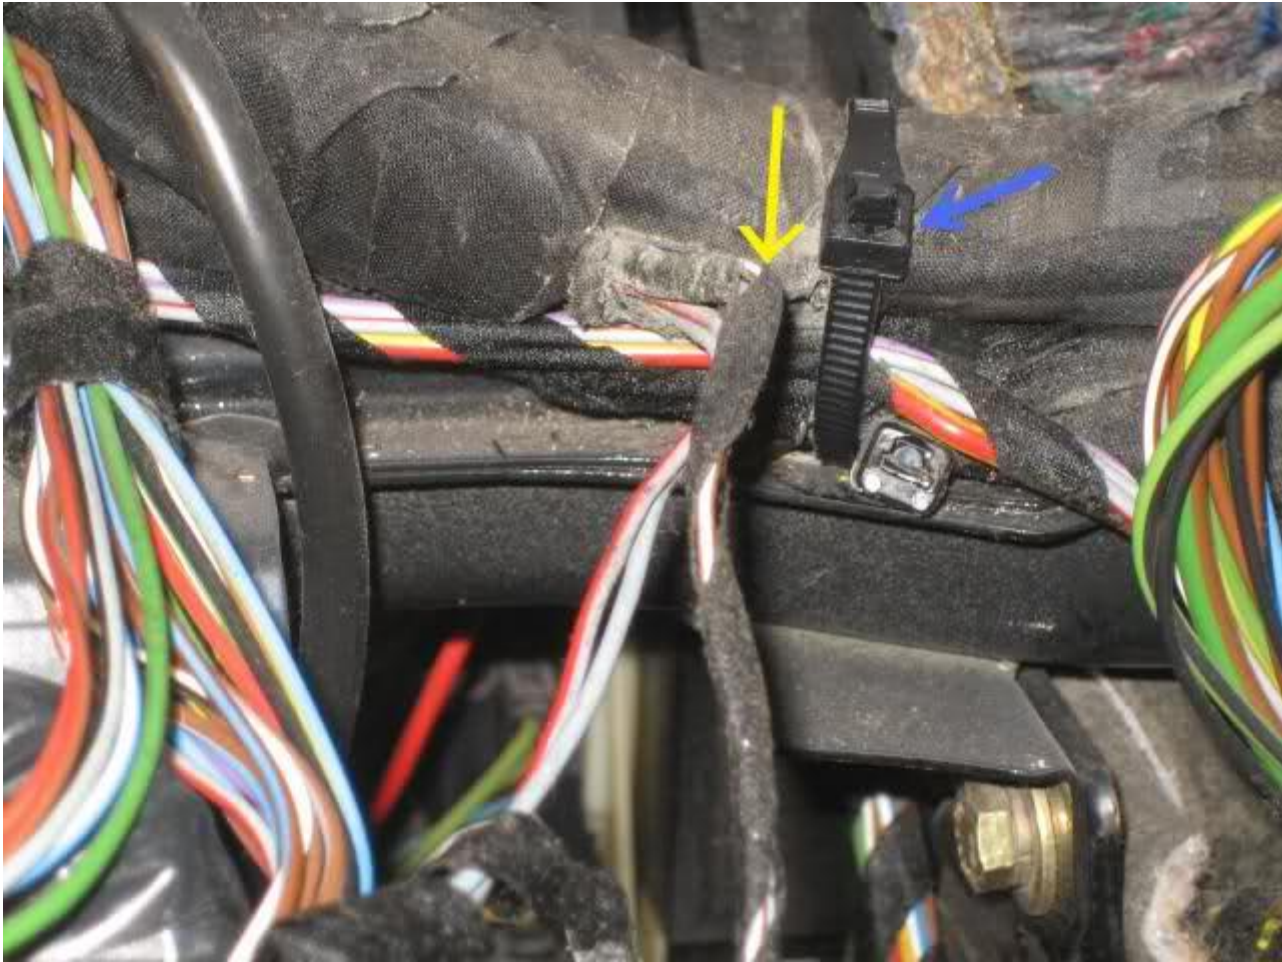
The biggest challenge was finding adequate working room to remove (by pulling straight toward the left of the car) the two female spade connectors on the rear of the fog light switch. I ultimately cut the zip tie (the blue arrow in the following photo) on the wiring bundle, releasing 1.5 inches of connector wiring (see yellow arrow), and then replaced the zip tie.

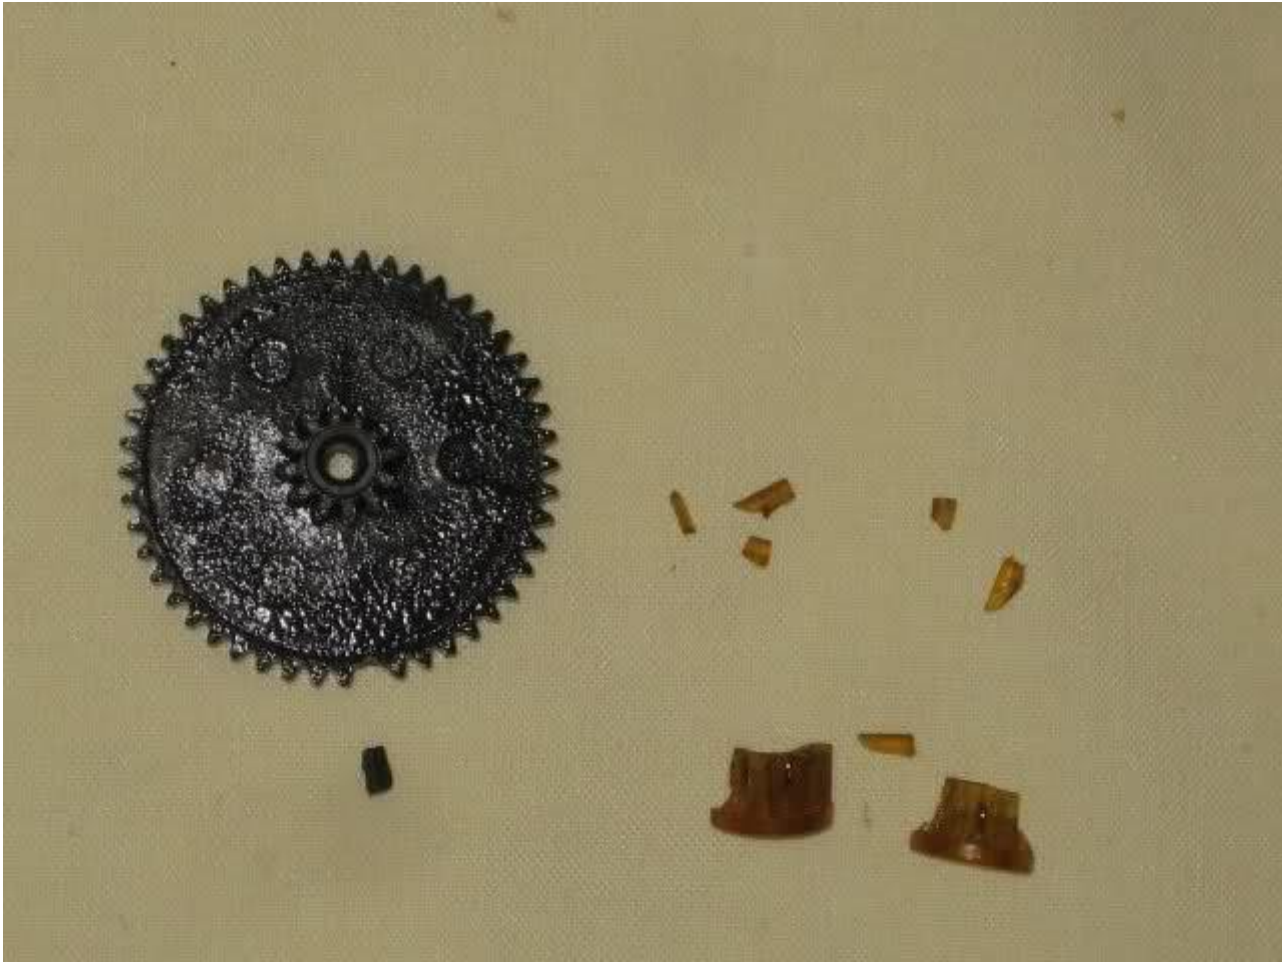
After removing the speedometer unit and gear cover panel, I retrieved all the visible pieces. Although all broken pieces were accounted for (see photo below), I blew out the unit with compressed air.

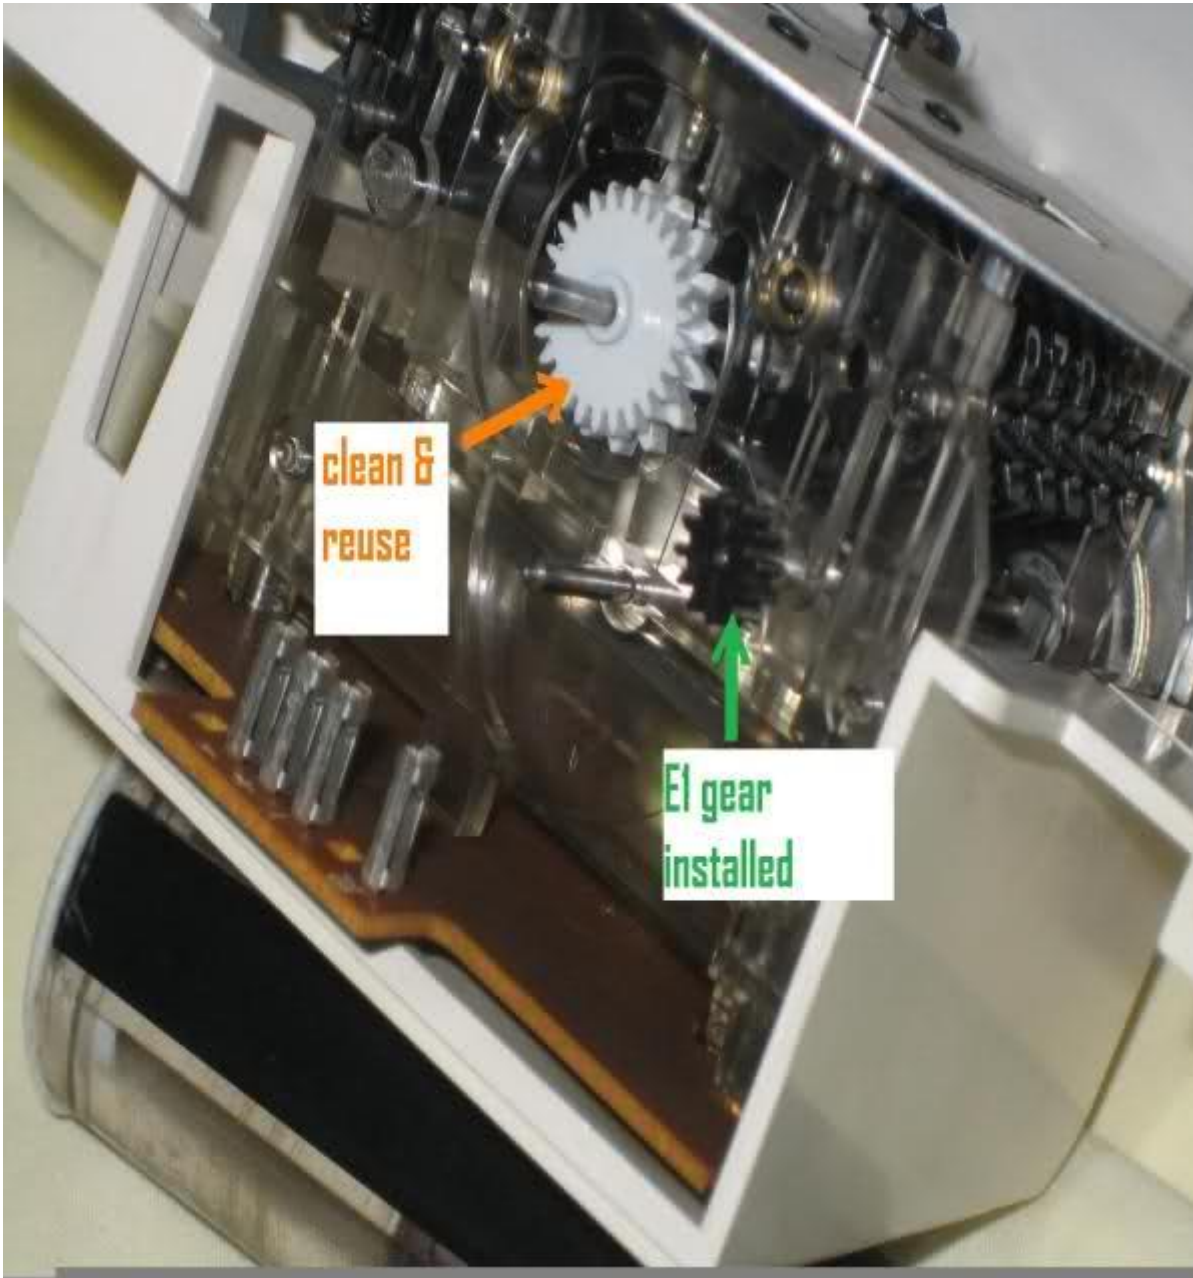
The following photo shows the innermost gear that must be cleaned (with rubbing alcohol) and reused. It also shows the new E1 gear installed after the press-fit brass bushing used with the old E1 gear had been removed. It wasn't necessary to cut the bushing, only deform it with side cutters and slip it off the shaft.

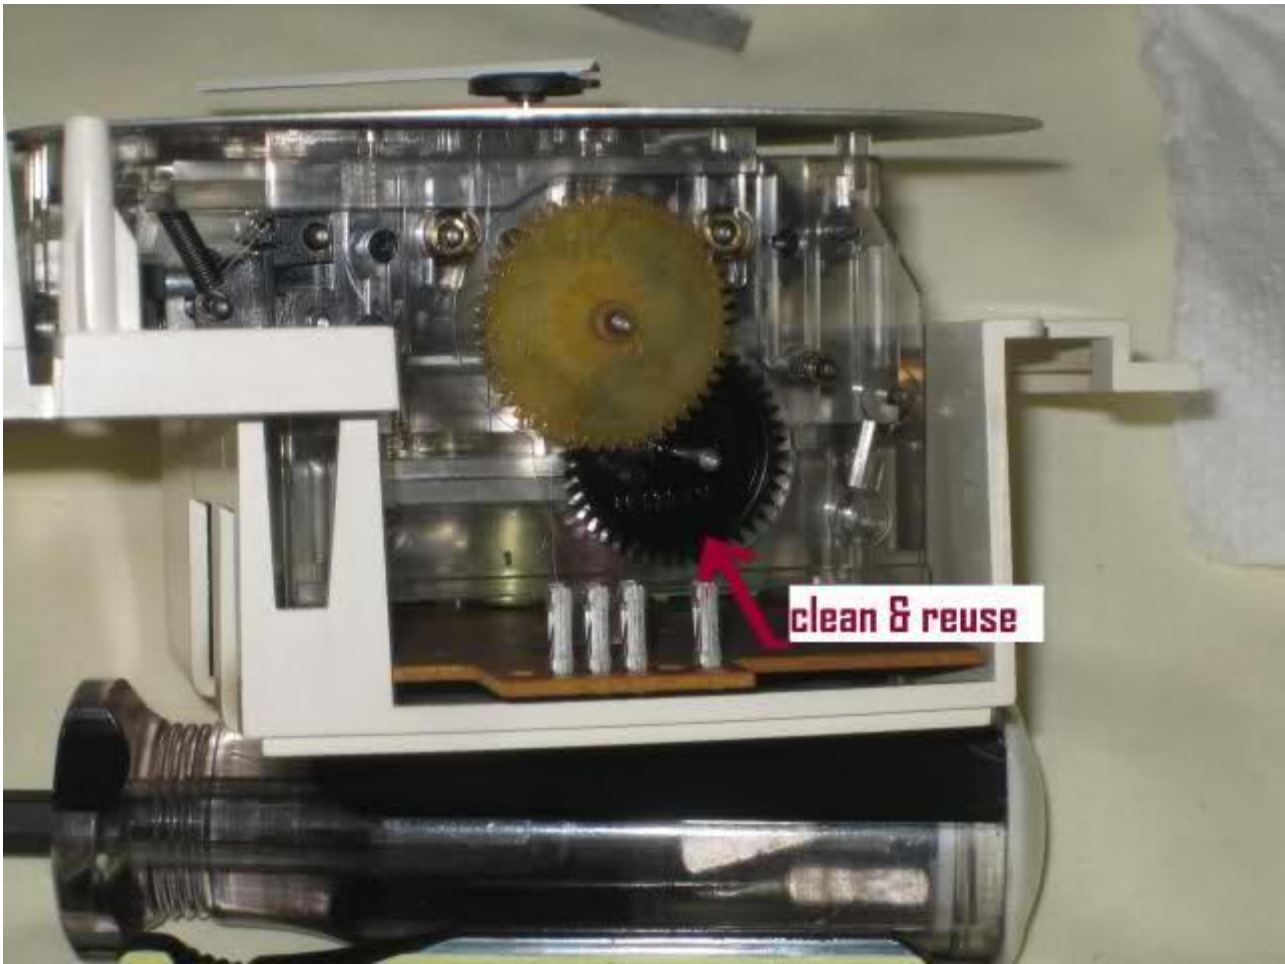
The photo below shows the other gear that must be cleaned and reused.

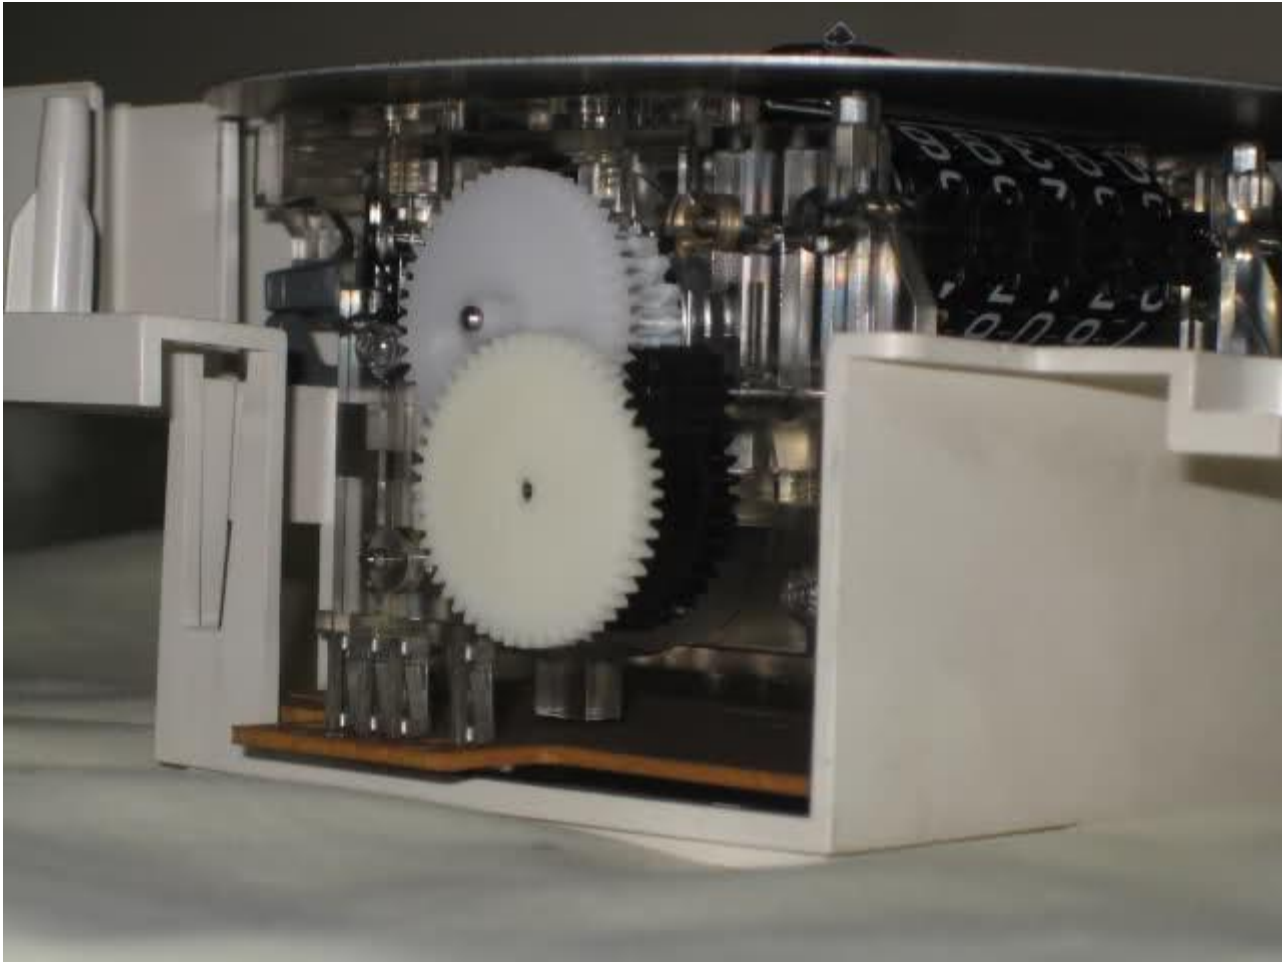
The following photo shows the new gears installed, just before replacing the clear plastic cover.

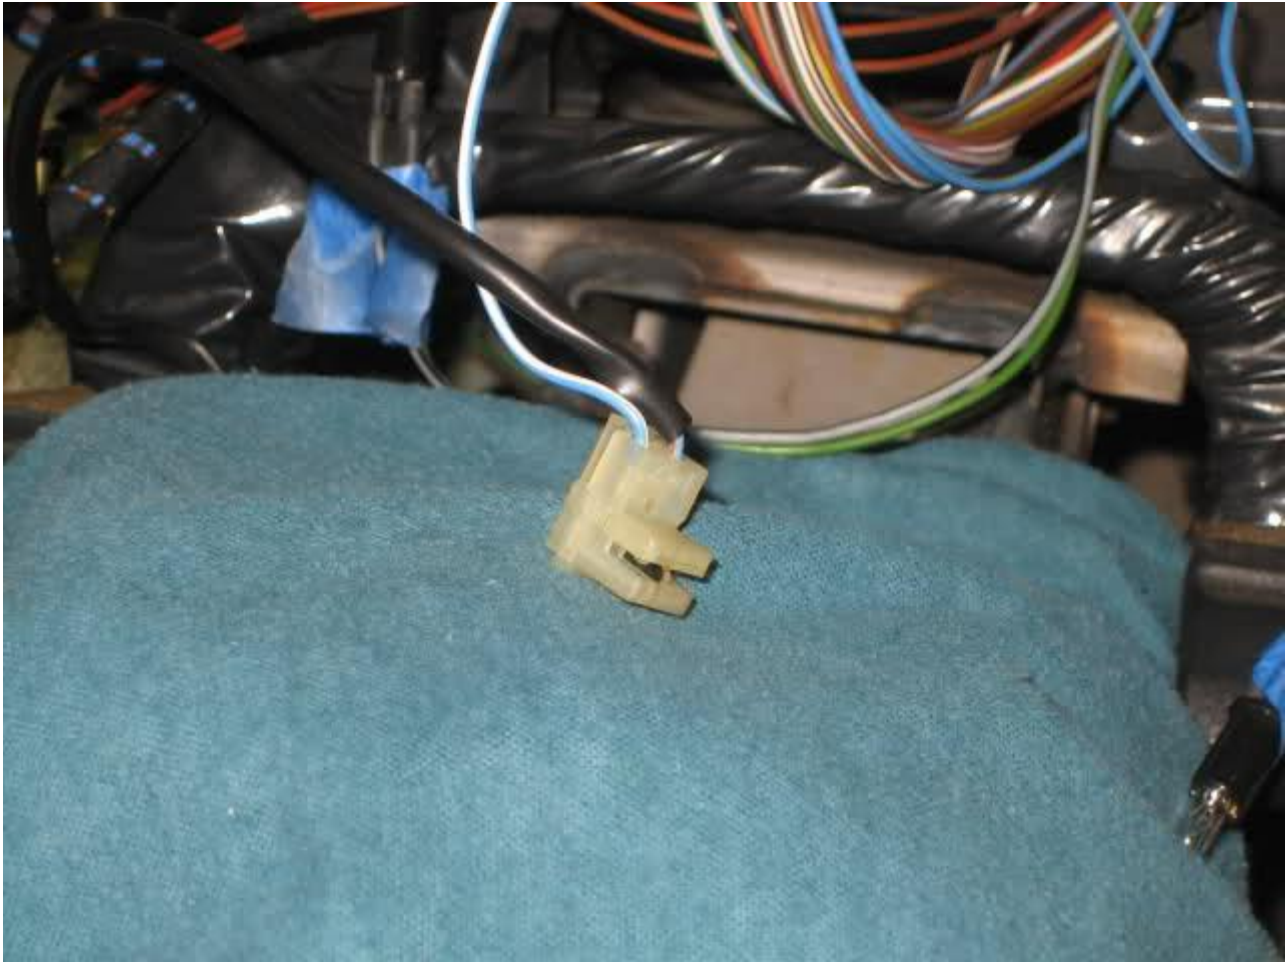
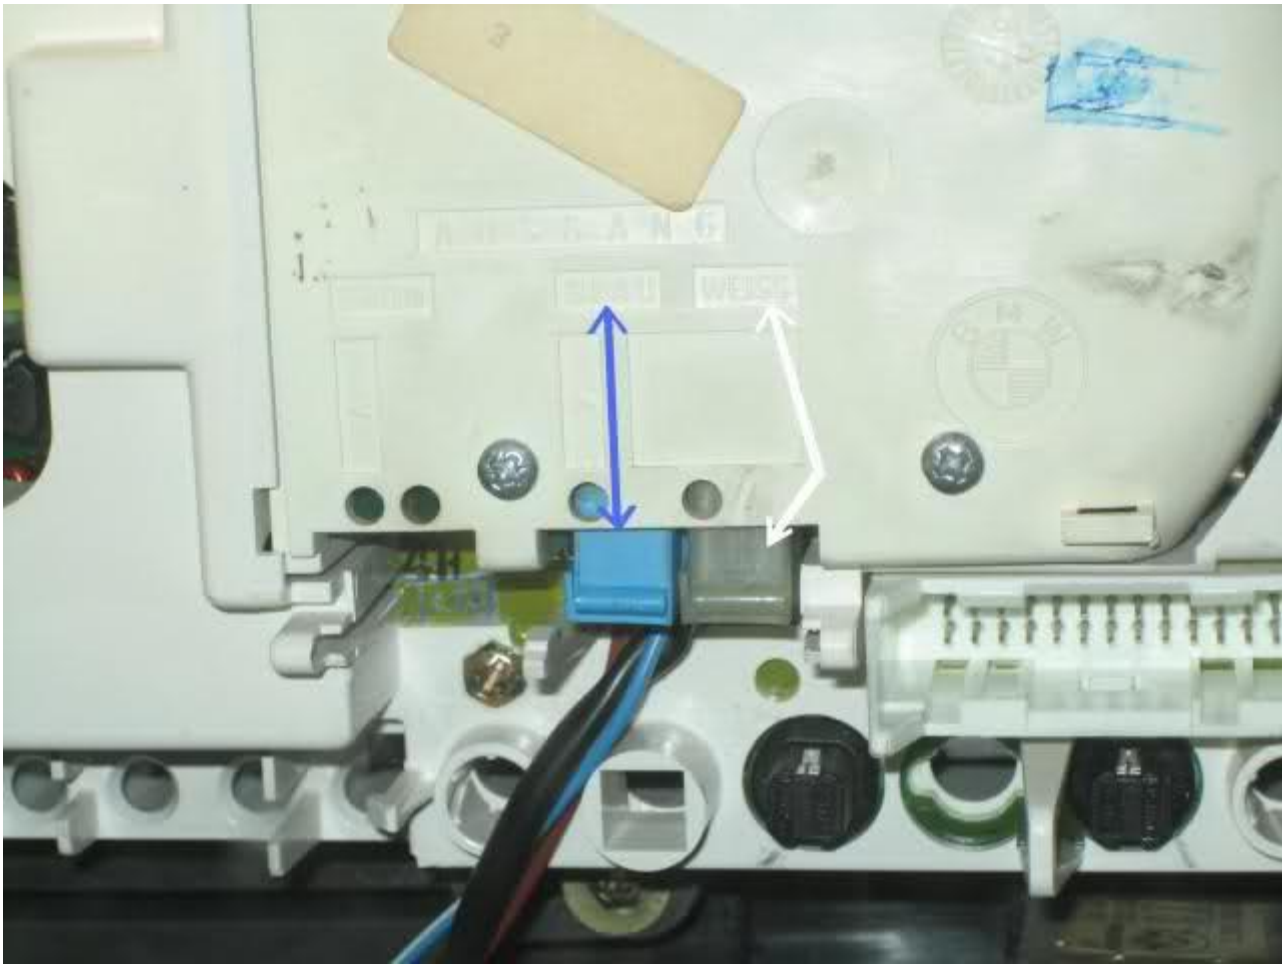
The only reassembly uncertainty was fitting the two small connectors for the odometer wires. They are color coded (blau/blue and weiss/white) and the color is also marked on the back of the cluster. See the following two photos.
