www.OdometerGears.com

Mercedes-Benz Electronic Odometer Gear Repair

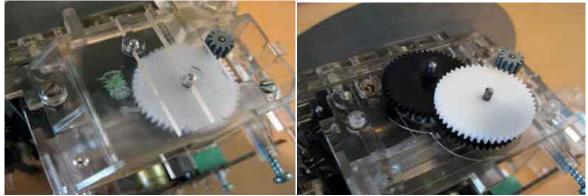
This is the side of the speedometer removed from the cluster. There are two small shiny flathead screws holding the clear plastic cover over the gears.

*First remove the clear cover *Remove all of the gears *Pull the two shafts out with pliers that the larger gears were on. !!!!!Do NOT try and remove the shaft that the twelve tooth drive gear is located On as this will damage the motor!!!!
